Minerals Inspection Report

Mine Name: Tetla Septarian Mine	Permit Number: S/025/0006	Mine Status: Reclaimed
Operator Name: Robert L. Harris	Inspection Date: 09/23/2014	Permit Fees: No Fee Req.
Inspector(s): Lynn Kunzler	Inspection Time: 10:30 am	Bond Amount: \$2,000
Attendee(s):	Weather:	Bond Escalation: na
Inspection Purpose: Check on reclamation status while in the area.		Prior Inspection: 06/18/2013

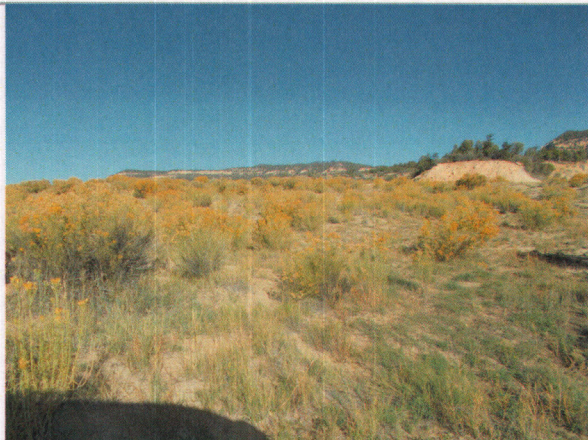
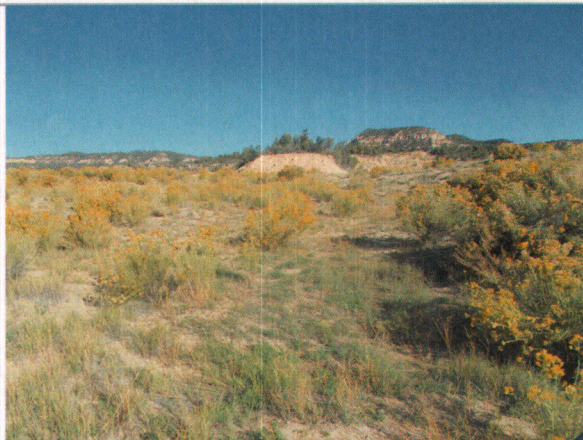
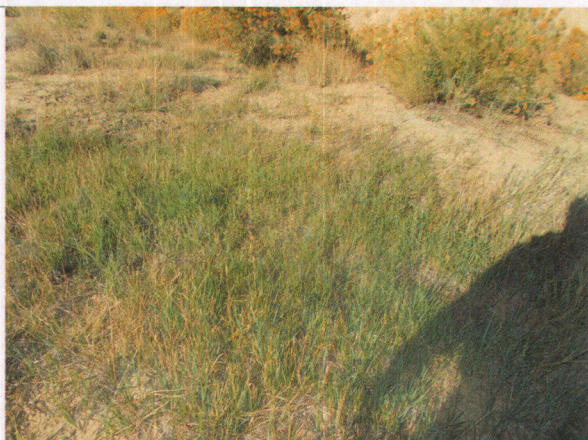
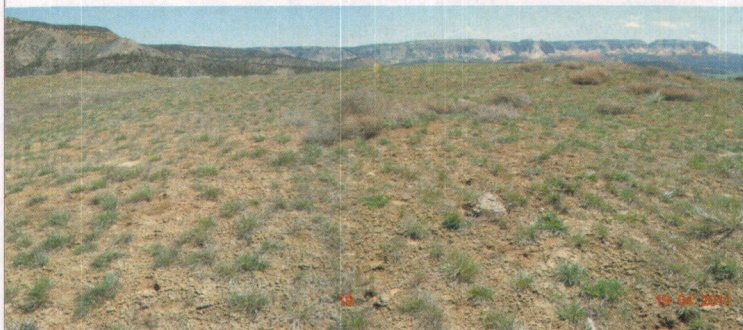
The site is stable and vegetation is well established, exceeding premining ground cover levels. All trash and equipment have been removed. It has been over 3 years since last seeding or other reclamation work was completed. It would be acceptable to release this site if the operator so requests.

2. <i>Public Safety (shafts, adits, trash, signs, highwalls)</i>	<input checked="" type="checkbox"/>	<input type="checkbox"/>
There were no shafts or adits associated with this project. Highwall blends in with existing premining slopes and is considered stable. There was no trash or debris observed on this site.

6. <i>Reclamation</i>	<input checked="" type="checkbox"/>	<input type="checkbox"/>
The site was reclaimed by regrading and seeding prior to 2011. All equipment has been removed from the site

9. <i>Revegetation</i>	<input checked="" type="checkbox"/>	<input type="checkbox"/>
Ground cover of the reclaimed area was in excess of 70% Pre-mine ground cover (as estimated from surrounding areas) was less than 40%. Therefore the revegetation standard has been met.

10. <i>Other</i>	<input checked="" type="checkbox"/>	<input type="checkbox"/>
The operator should request full release at this time, unless he plans to reopen the mine. Since this is on SITLA lands, their concurrence for release must be recieved.
